# Analysis of Fault Zones Associated with Large Earthquakes in South African Gold Mines

Preliminary report

Ori Dor & Ze'ev Reches, Earth Sciences Institute, Hebrew University, Jerusalem, Israel

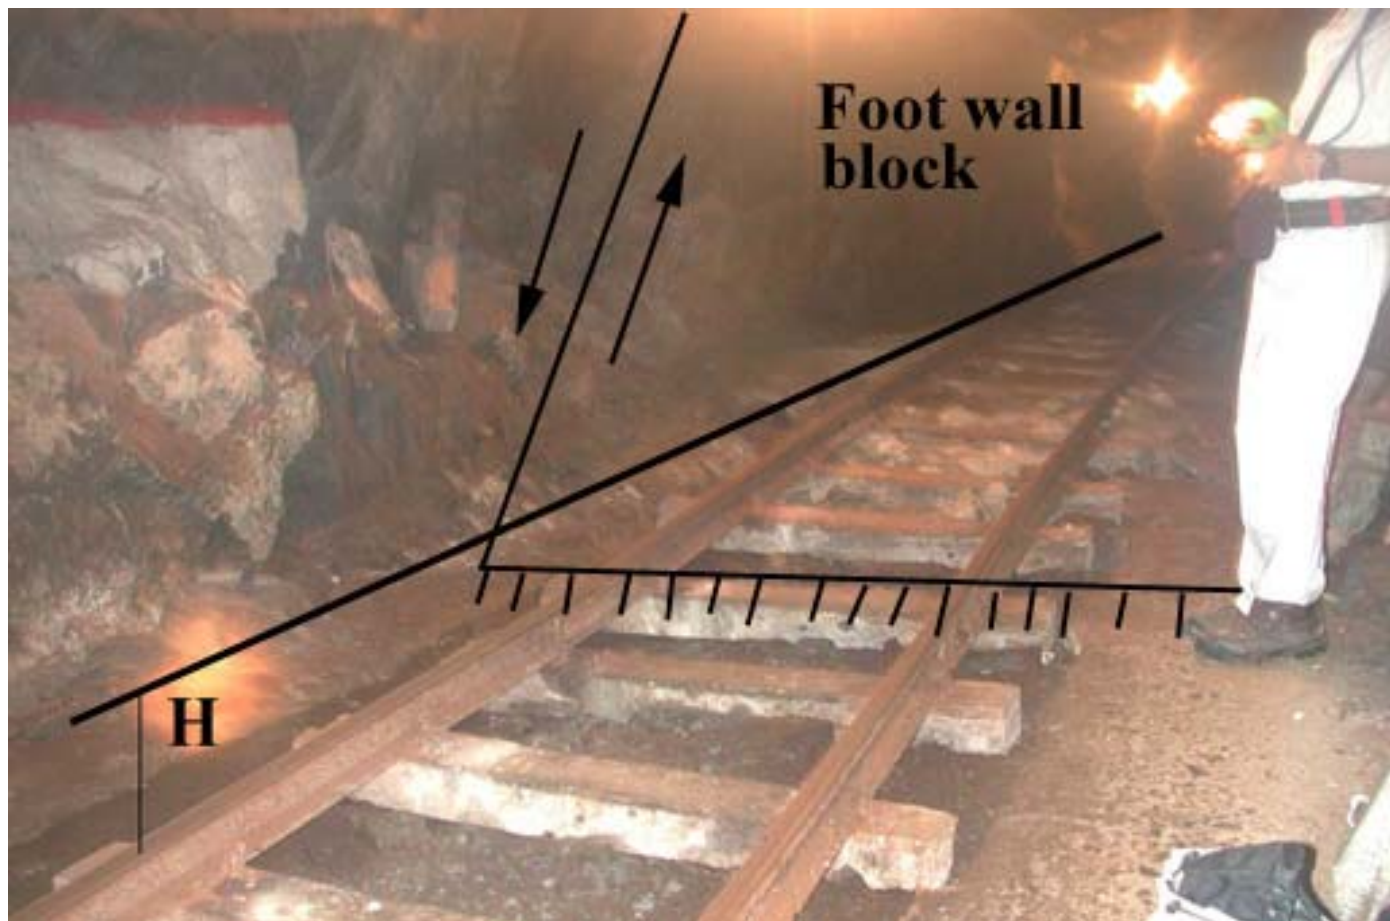
The tunnel at this site was reconstructed after the earthquake and most of the damage products were removed. The local dip of the fault is  $37^{\circ}/253^{\circ}$ , roughly normal to the local inclination of the quartzite layers. The local slip is normal dip-slip. We measured the vertical displacement of the rail tracks (H in [Fig. 1](#)) to find  $H = 44$  cm across the fault; this estimate is 24 cm larger then the post earthquake survey results (van Aswagen, personal communication). The apparent displacement increase by 24 cm could indicate post seismic slip along the Dagbreek fault. To verify this option, we will conduct an accurate geodetic survey of accessible portions of the Dagbreek fault with an EDM instrument. This is a total station system with resolution of  $\pm 2$  mm. We carefully examined the tunnel walls and could recognize slip-surfaces and displaced blocks to distance of up to 45 m from the main fault, but only in the foot wall block.

Fig. 1. Displaced tracks in site 1, level 45, Eland shaft. H indicates the vertical displacement across the fault zone (line with short bars). Distributed damage (fractures and crushed zones) were found primarily in the uplifted foot wall.

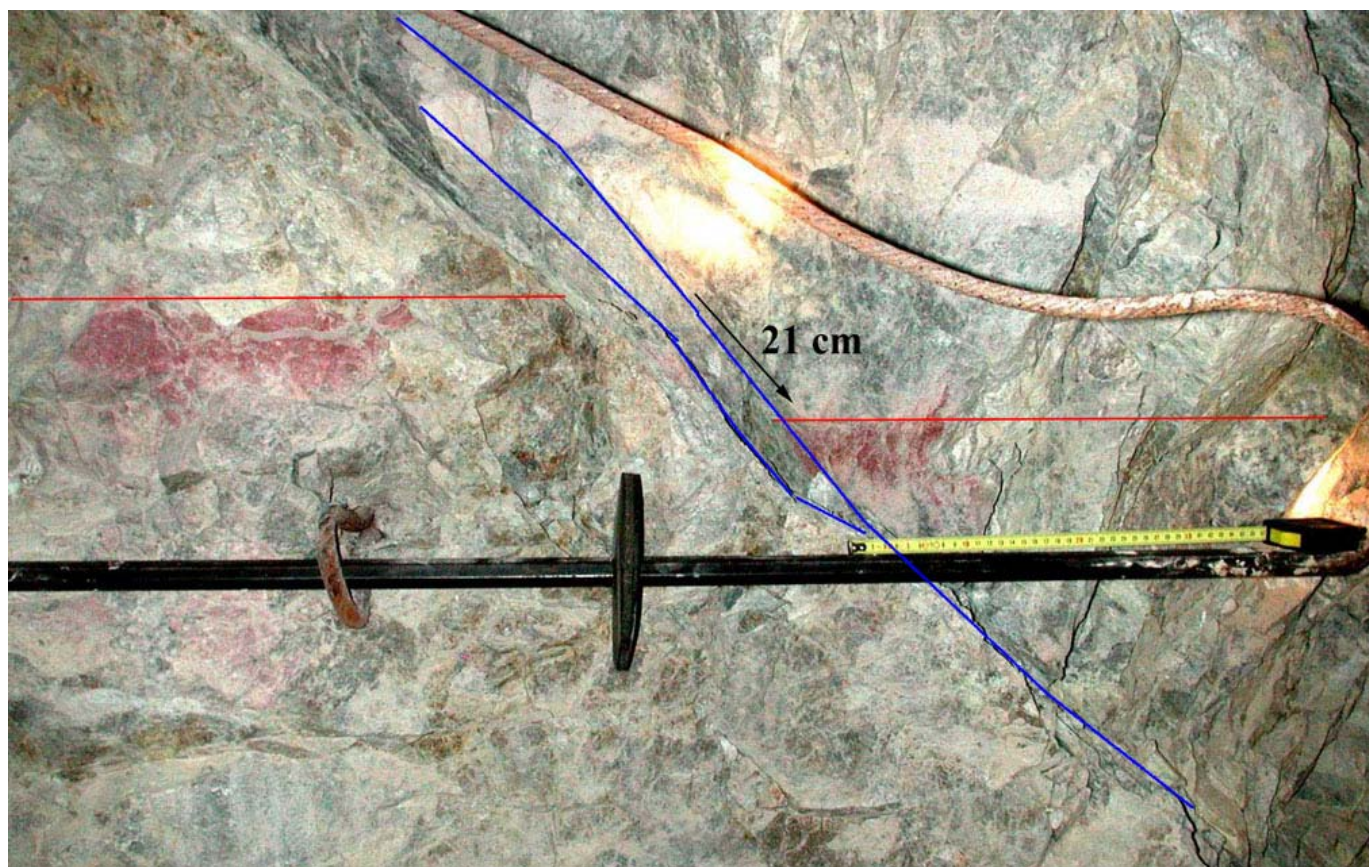
Site 2 is located on the Dagbreek fault, about 500 m south of Site 1. This area was highly damaged during the earthquake with no cleaning and recovery and the exposures are restricted to a small region. We identified here a fault-zone of 9.5 m width which is controlled by the local accessibility; actual width is most likely larger (see site 3 below). We found several small slip-surfaces with displacements of 0.5 cm and smaller, most of them have a thin clayey gouge zone (pyrophyllite?). The “rock flour” gouge is not common here (unlike in site 3). Slickenside striations in various directions and scales are distributed on most of the slip-surfaces; some of the striations could form in previous events. It is also possible that the odd striations reflect movement into the open tunnel during the 1999 earthquake. The main slip-surface here displays 21 cm of dip-slip as evident by the displacement of the red line ([Fig. 2](#)). The 21 cm slip is distributed within 3-5 cm thick fine grain gouge zone (pyrophyllite?).

Many broken rock bolts are observed at this site. Apparently, these rock bolts did not yield only in the event of April 1999, and some of them yielded in previous events or by creep. The possibility of on-going damage at this site will be investigated. Some rock bolts that penetrated into and parallel to the slip-surfaces surprisingly do not display evidence for deformation or shear. The intense damage at this site may be related to site effect associated with the Y shaped local tunnels or may reflect the damage heterogeneity close to the tip of a propagating earthquake.

Fig. 2. The main slip-surface (blue line) dipping to the west in site #2. The red line is displaced by 21 cm of dip-slip along the thick gouge zone.

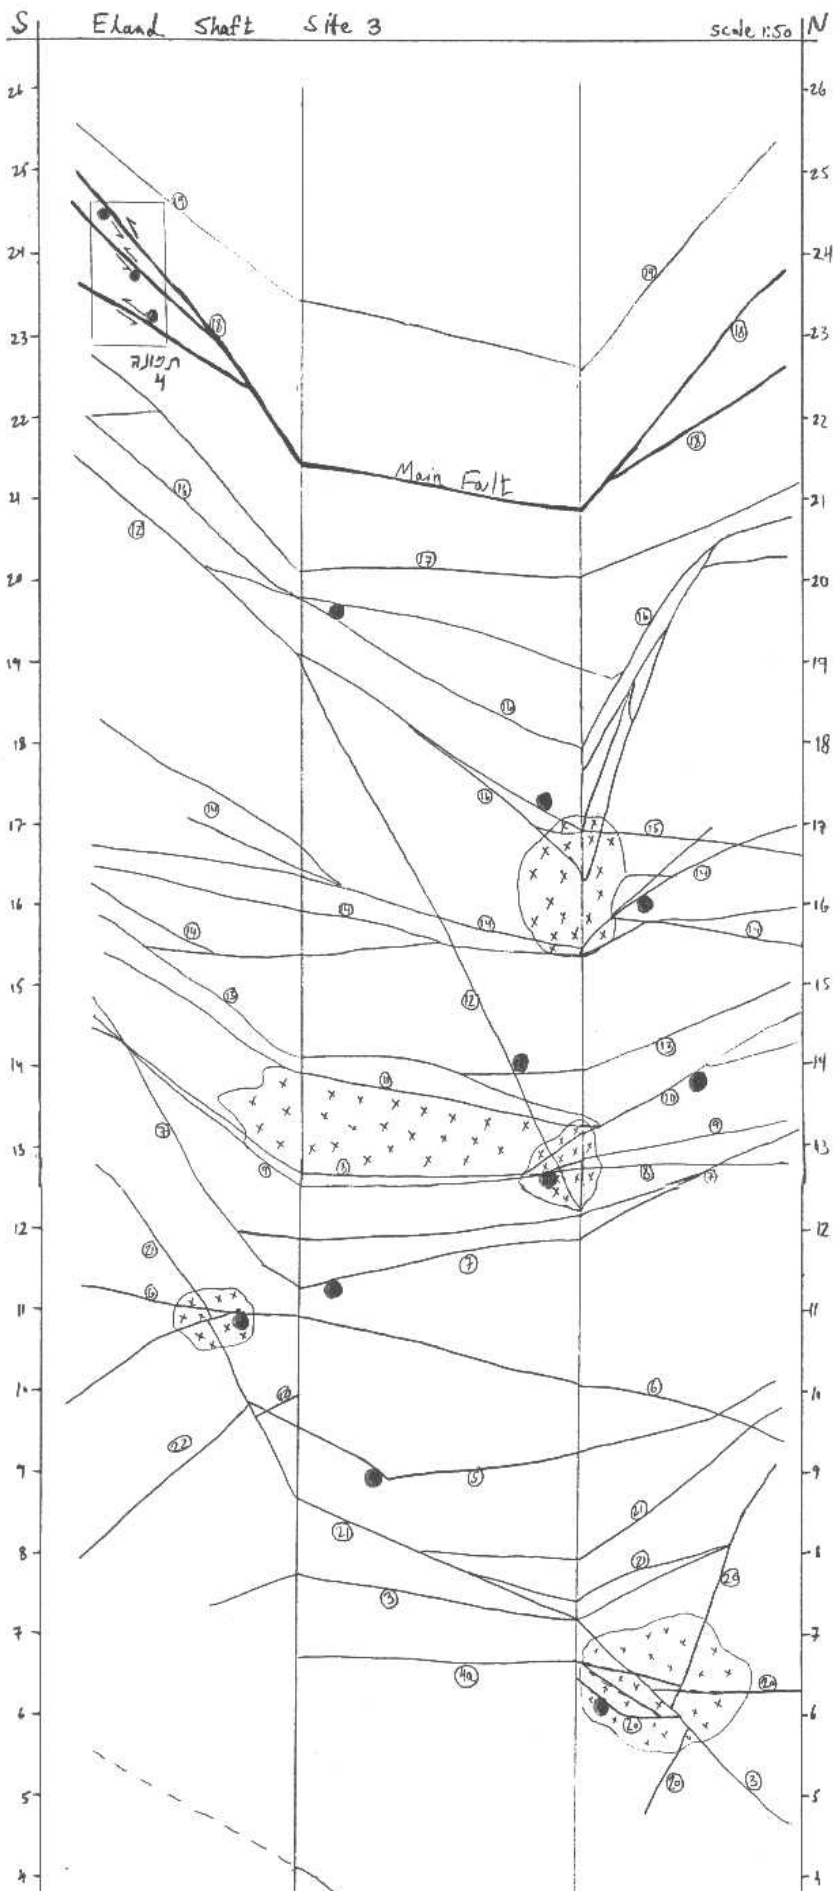
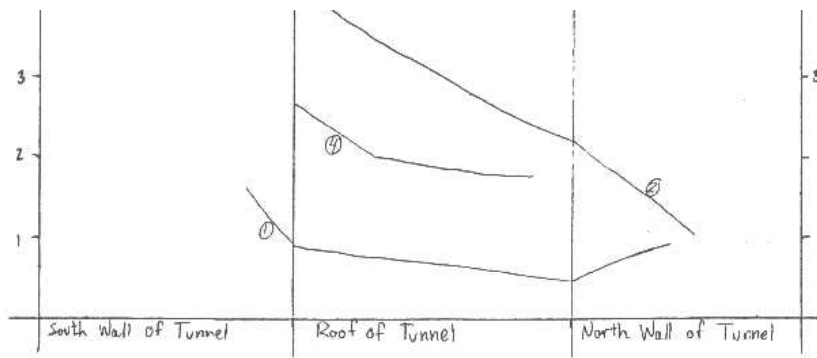
The fault-zone includes about twenty slip-surfaces generally dipping westward and arranged in five clusters (Fig. 3). Most of these slip-surfaces (excluding fault #18 that will be described below) are coated with white “rock flour” of comminuted quartzite of the host rock [3]. Similar powder+fragments mass was found in Hartebeestfontein mine [5] (see below).

Fig. 3. Map of slip surfaces (solid lines) of the Dagbreek fault at site 3. The central panel is the tunnel top with south and north sidewalls on left and right, respectively. Scale in meters; black dots indicate point of slip indicator; heavy line indicates fault #18; (Archean gouge-zone); areas with small cross indicate intense fracturing.

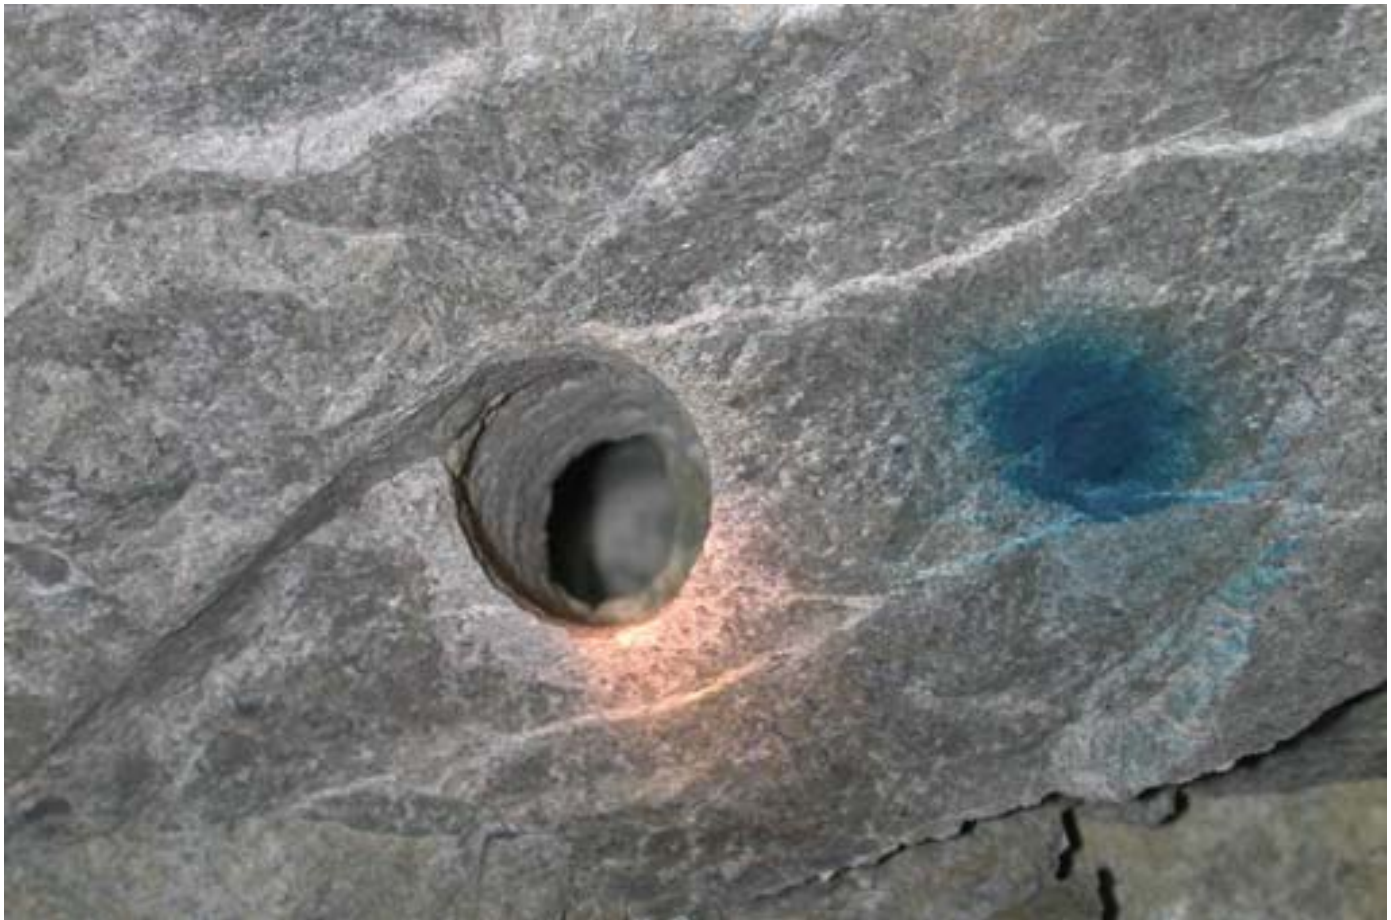
One type of evidence for slip are the displaced boreholes of rock bolts in which both dip-slip and strike-slip components of the displacement could be evaluated (Fig. 4). We found displaced boreholes at 10 slip-surfaces and they revealed slip from 0.5 cm to 6 cm. The sense of slip and the orientations of the surfaces diverse significantly between the individual surfaces; we found evidence for right-lateral, left-lateral, normal and reverse motion. These contradicting slip directions will be investigated in the future.

Fig. 4. Displaced borehole at site 3. Upward view on the roof; the slip-surface is sub-parallel to the roof; displacement about 15 mm.

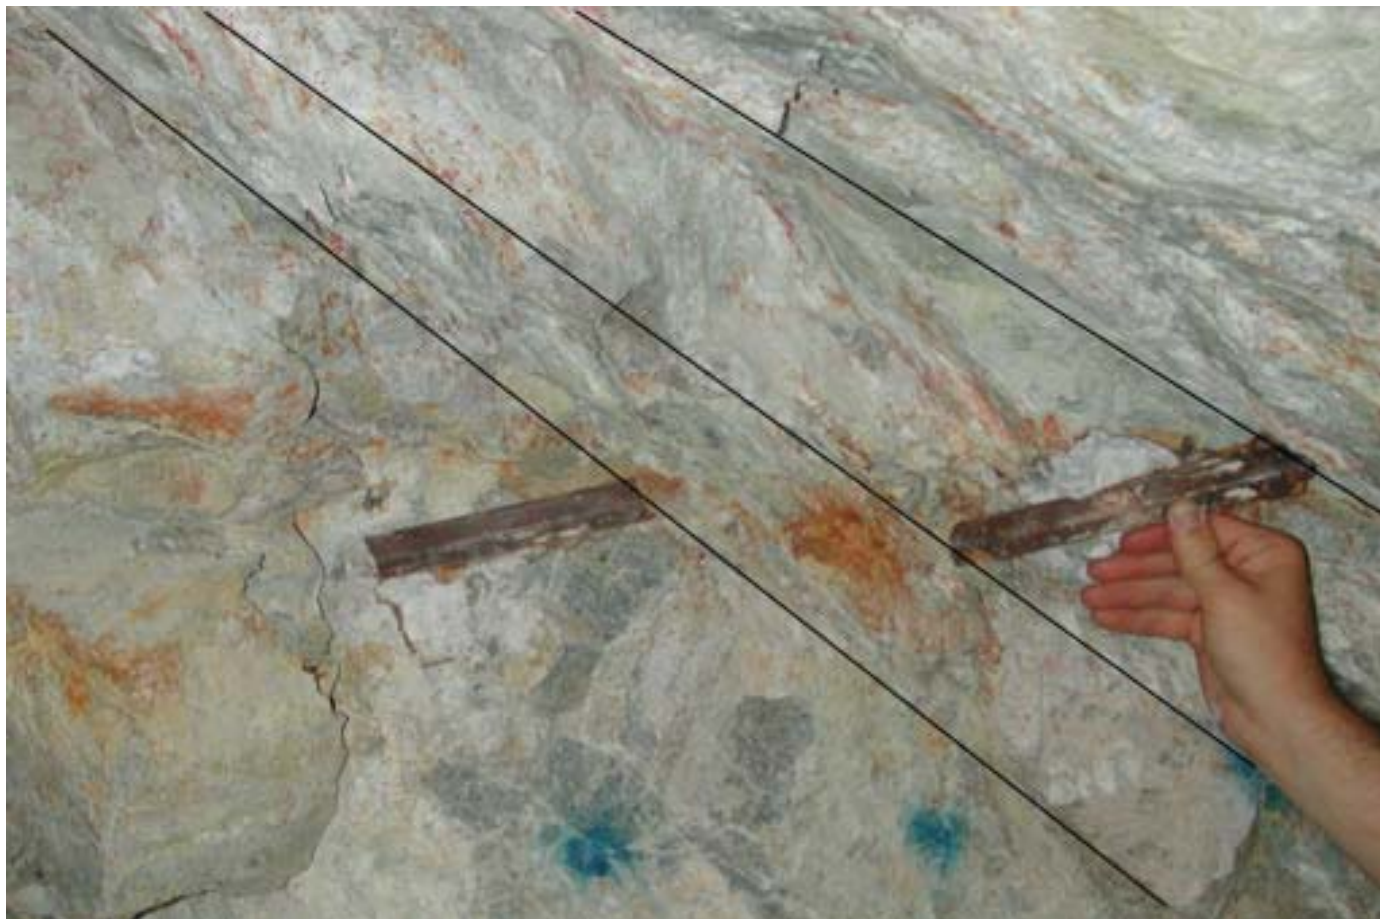
Probably our most amazing finding was observed inside the Archean fault-zone of Dagbreek fault (fault #18 in Fig. 3). This is a 25 cm thick gouge-zone of pyrophyllite with quartzite fragments and it dips  $26^\circ/280^\circ$ . A steel drill bit used for rock bolting was left inside this gouge-zone during the tunnel, and it was “chopped” into four pieces during the earthquake (Fig. 5). The broken pieces were found in the rubble, immediately below their original position. Using rust stains, we reconstructed the pieces to their position and measured 11 cm of dip-slip and 5 cm of right-lateral slip accumulated three crosscutting slip-surfaces within the gouge-zone (Fig. 5). To the best of our knowledge, this is a unique observation in earthquake research and its

Fig. 5. The Archean fault zone of Dagbreek fault system at site 3. The gouge-zone here is 25 cm thick, and it cut the steel drill bit (see text).

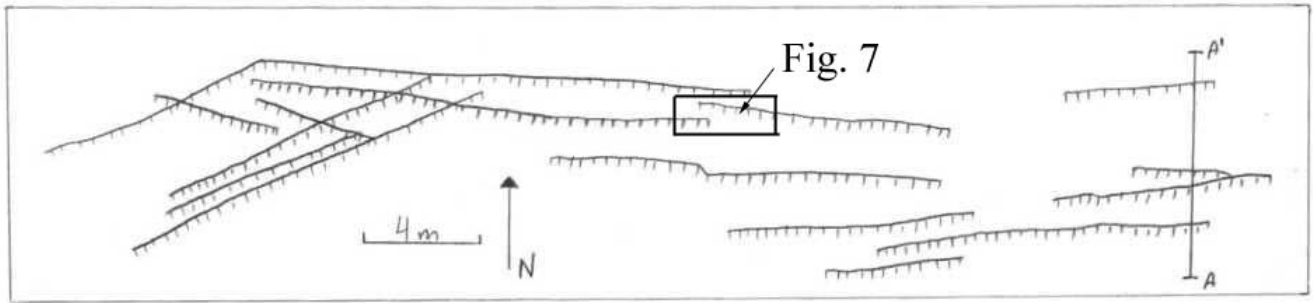
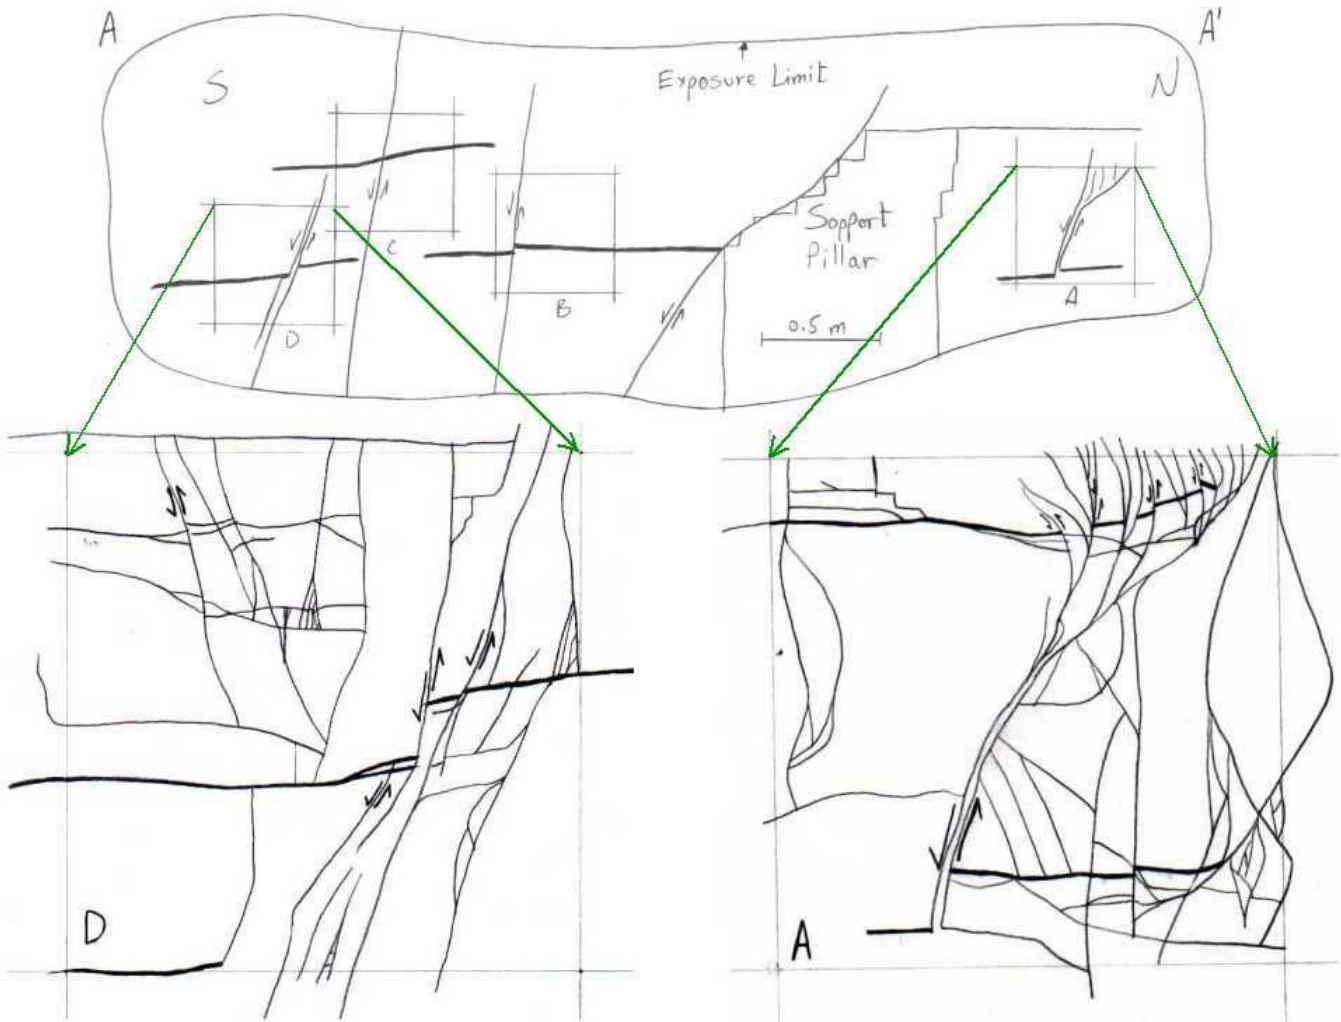
This is a normal fault-zone with cumulative dip-slip of at least 25 cm. It is 6-8 meter wide, with 6-9 sub-parallel slip-surfaces that dip  $60^{\circ}$  - $85^{\circ}$  and display zigzag pattern (Fig. 6). Crosscutting relations and conjugate occurrence occur at several scales (see Fig. 6 and details in Fig. 7). The slip-surfaces are always coated with white powder of comminuted quartzite of the host rock. SEM pictures show pervasive indicators of slip inside the powder mass. Our surface-area measurements of the undisturbed powder revealed values of about 6 m<sup>2</sup>/gr, hundreds of times the surface-area of the intact rock. Locally, the slip-surfaces are zones up to 10 cm thick composed of the white powder and rock fragments.

Fig. 6. Maps and cross-sections of Bosman fault, Hartebeestfontein mine. The map is shown in the upper part, general cross-section in the center and two detailed sections below; lines with bars indicate faults (bars on downside), heavy lines indicate layering; note scale bars of 4.0 m in map and 0.5 m in general cross-sections.

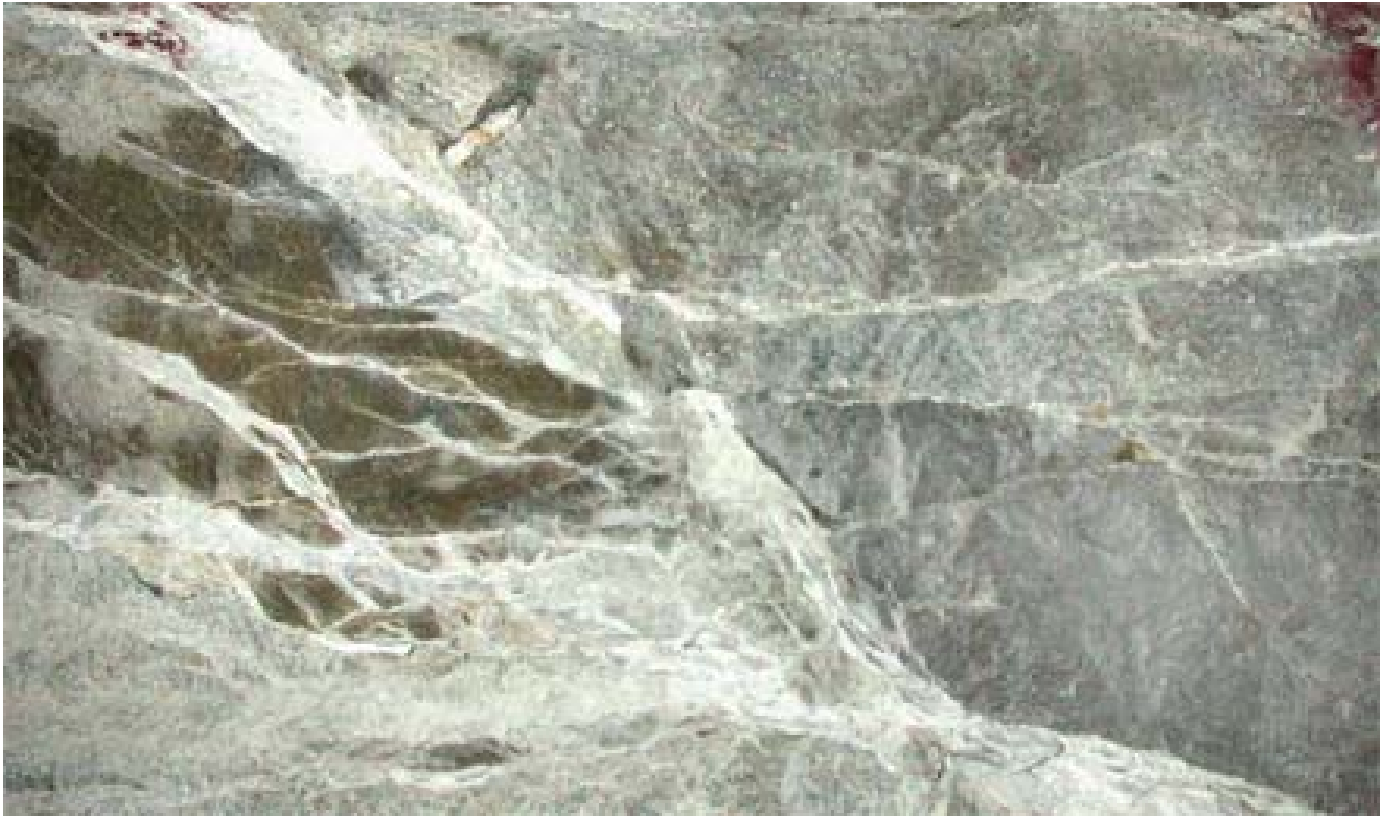
Fig. 7. View on tunnel's roof in the Bosman fault-zone. Note dense pattern of cross-cutting, zigzagging slip-surfaces of several scales; width of photo is about 1 m (see also figures in [3] and [5]).
