Fault zones associated with the Matjhabeng earthquake, 1999, South Africa

O. DOR*, Z. RECHES*, and G. VAN ASWEGEN†

We mapped portions of the Dagbreek fault in Matjhabeng mine (Eland shaft, Welkom) that slipped during the 1999 Matjhabeng earthquake. The fault-zone that was active during this event is up to 30 m wide (and probably more) and it contains tens of gouge zones that are characterized by the well-known 'rock flour' and quartzite fragments. The slip on an individual gouge zone ranges from a few millimetres to 21 cm, and the largest measured total displacement along the Dagbreek fault is 44 cm. This displacement is of the same order as the maximum displacements measured after similar earthquakes in the Welkom gold field over the past 27 years.

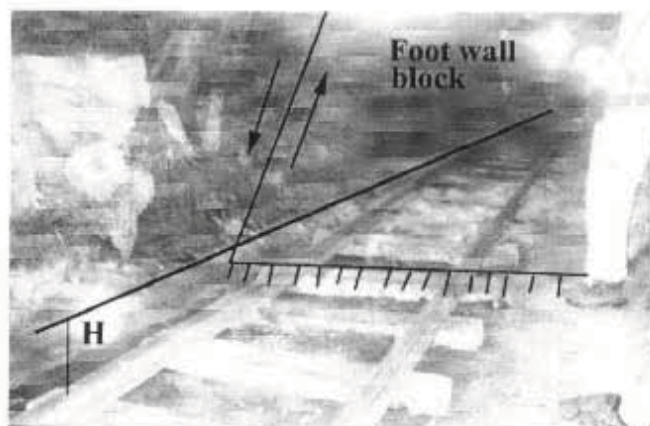
The tunnel at this site was repaired after the earthquake and broken rock that littered the tunnel after the tremor had been removed. The local dip of the fault is 37°/253°, roughly normal to the local inclination of the quartzite layers. The local slip is normal dip-slip. We measured the vertical displacement of the rail tracks (H in Figure 3) as H = 44 cm across the fault. We examined the tunnel walls and could recognize slip-surfaces and displaced blocks to a

distance of up to 45 m from the main fault, but only in the footwall of that part of the fault zone shown in Figure 3.

Figure 3. Displaced tracks at site 1, level 45, Eland shaft. H indicates the vertical displacement across the Dagbreek fault zone (line with short bars). Distributed damage (fractures and crushed zones) were found primarily in the uplifted footwall side of the fault zone

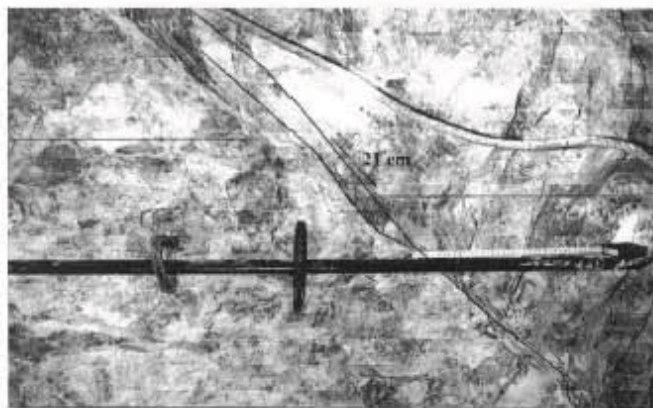
and below). We found several clayey, soft gouge zones with displacements of 0.5 cm and smaller. Slickenside striations in various directions and scales are distributed on most of the gouge zones; some of the striations could have formed during previous events. The largest localized slip measured is 21 cm of dip-slip as evident by the displacement of the reference line in Figure 4. The 21 cm slip is distributed within 3–5 cm thick, fine grained and fresh gouge zone.

Many broken rock bolts are observed at this site. Apparently, these rock bolts did not yield only in the event of April 1999; some of them apparently yielded previously by creep. Some rock bolts that penetrated into, but parallel to the gouge zone surprisingly do not display evidence of deformation or shear. The intense damage and complex deformation history referred to here, are possibly related to a site effect associated with the Y-shaped local tunnel configuration. It may also reflect the damage heterogeneity close to the tip of a propagating earthquake.

Figure 4. The main slip-surface (thick line inclined to the right) dipping to the west in site #2. The horizontal reference line is displaced by 21 cm of dip-slip along the thick gouge zone

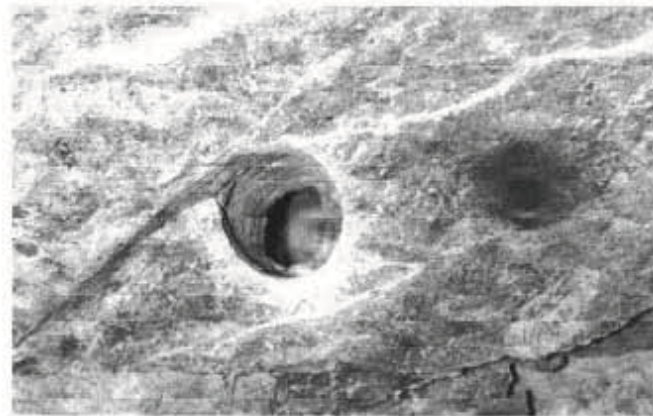
One type of evidence for slip are the displaced boreholes of rock bolts in which both dip-slip and strike-slip components of the displacement could be evaluated (Figure 5). We found displaced boreholes at 10 places and they revealed slip from 0.5 cm to 6 cm. The dominant gouge zone of the Dagbreek subsurface rupture in this tunnel is 50 cm thick, pyrophyllite-rich with quartzite fragments. It dips 26°/280°. We used the present disposition of pieces of a drill-rod that had penetrated this zone and served as an excellent displacement marker, to measure 11 cm of dip-slip and 5 cm of right-lateral slip within this gouge-zone.

Figure 5. Displaced borehole at site #3. Upward view on the roof; the slip-surface is sub-parallel to the roof; displacement about 15 mm
