Fault zones associated with the Matjhabeng earthquake, 1999, South Africa

O. DOR*, Z. RECHES*, and G. VAN ASWEGEN†

We mapped portions of the Dagbreek fault in Matjhabeng mine (Eland shaft, Welkom) that slipped during the 1999 Matjhabeng earthquake. The fault-zone that was active during this event is up to 30 m wide (and probably more) and it contains tens of gouge zones that are characterized by the well-known 'rock flour' and quartzite fragments. The slip on an individual gouge zone ranges from a few millimetres to 21 cm, and the largest measured total displacement along the Dagbreek fault is 44 cm. This displacement is of the same order as the maximum displacements measured after similar earthquakes in the Welkom gold field over the past 27 years.

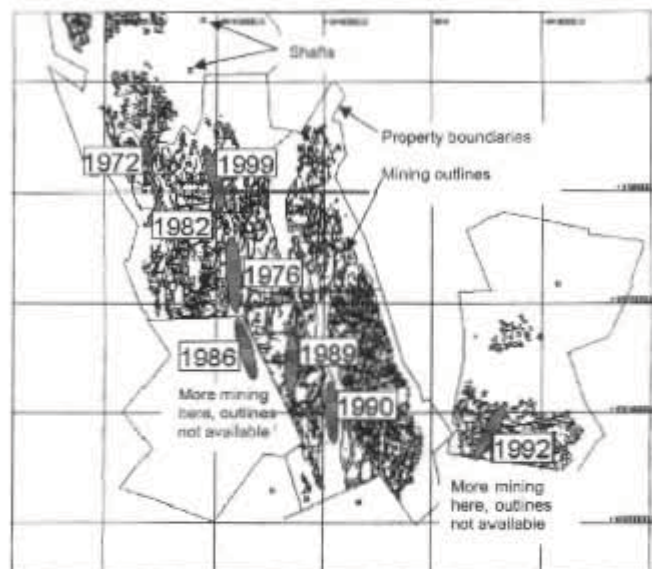
The major fault zones have been the sources of several earthquakes during the past three decades (Figure 1). The Welkom earthquake of 1976 made history because a multi-story building near its epicentre was destroyed. After the earthquakes, displacements of tens of centimetres were measured along several of the fault zones indicated in Figure 1. The opportunity to make accurate observations of the co-seismic slip were, generally, limited, either by severe underground damage or by the lack of tunnels intersecting the faults specifically in the source regions. The measured

Figure 1. The distribution of tremors > magnitude 4.6 in the Welkom gold field. The outlines of mining faces shown are those along Basal reef, that dips at an average of 20° to the east and is mined at an average depth of 2000 m below surface. All these tremors had a normal slip mechanism. The ellipses indicate the approximate sizes and shapes of the areas of significant co-seismic displacement (van Aswegen³). The co-ordinate grid spacing is 5 km

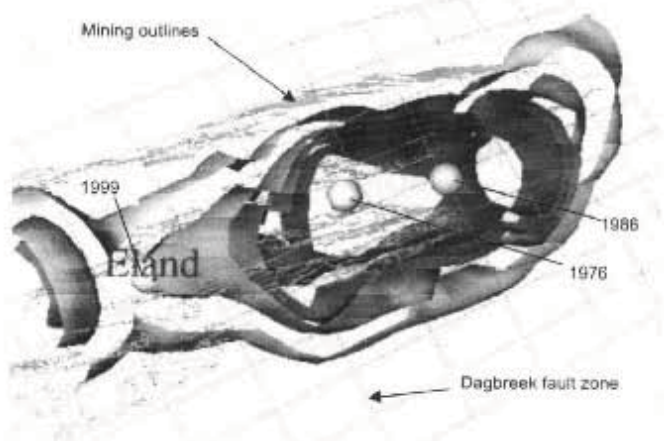
The tremor occurred along a part of the fault zone lacking in significant prior seismic deformation—a seismic gap was defined by contours of seismic Deborah number^{5,6} (Figure 2). Temporal patterns of micro-seismicity in the area of Eland shaft prompted an 'Alert level 2' advisory issued by the local mine seismic centre several days before the earthquake. This advisory was confirmed a day before the earthquake⁵.

Figure 2. A perspective view of the Dagbreek fault zone and 3D contours of seismic Deborah number², indicated the existence of a seismic gap in the area of Eland shaft prior to the Matjhabeng earthquake³. The view is down towards the south-east. The length of the fault zone is estimated at 50 km. Here a 10 km portion is depicted by the coarse mesh. The contours are based on thousands of seismic events spatially associated with the Dagbreek fault zone for the period since recording started in 1988 till just before the Matjhabeng earthquake. The 1976 and 1986 events were added to the data set based on source parameters from the S.A. Council for Geoscience. The spheres indicate only the approximate hypocentres of the large events, not their sizes
